USDA Hurricane Mitch Recovery Program, Special Objective 1—
Damaged Rural Watersheds Rehabilitated through Strengthened Local Capacity.

B. Country Program Description--Nicaragua

Program Background and Objectives

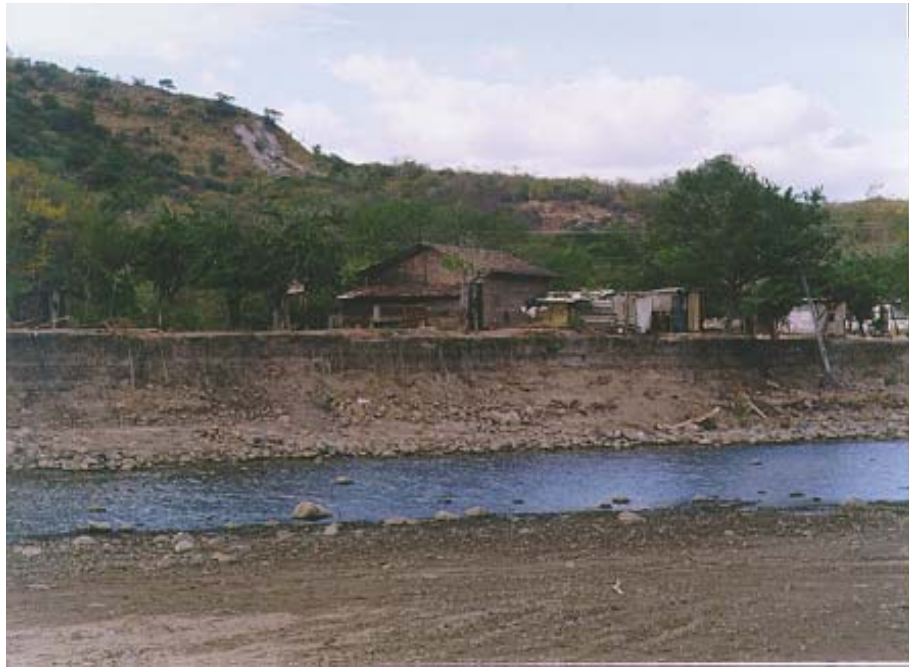
Figure 3. Streambank damage from Mitch put this small community at high risk for loss of life and property in future storms

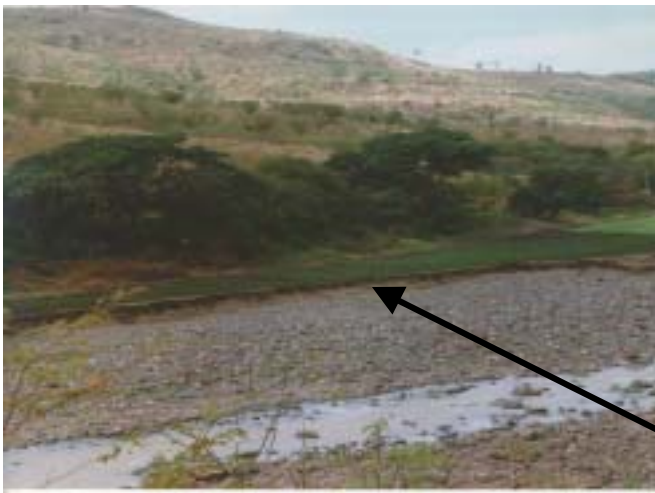
Figure 4a. Mitch washed away crops leaving gravel where productive crops once stood

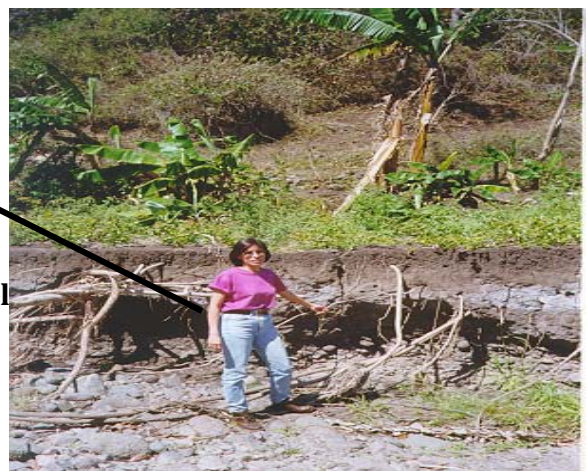
Figure 4b. (Close-up of 3a) Thousands of tons of soil was lost when Mitch floods scoured existing watercourses

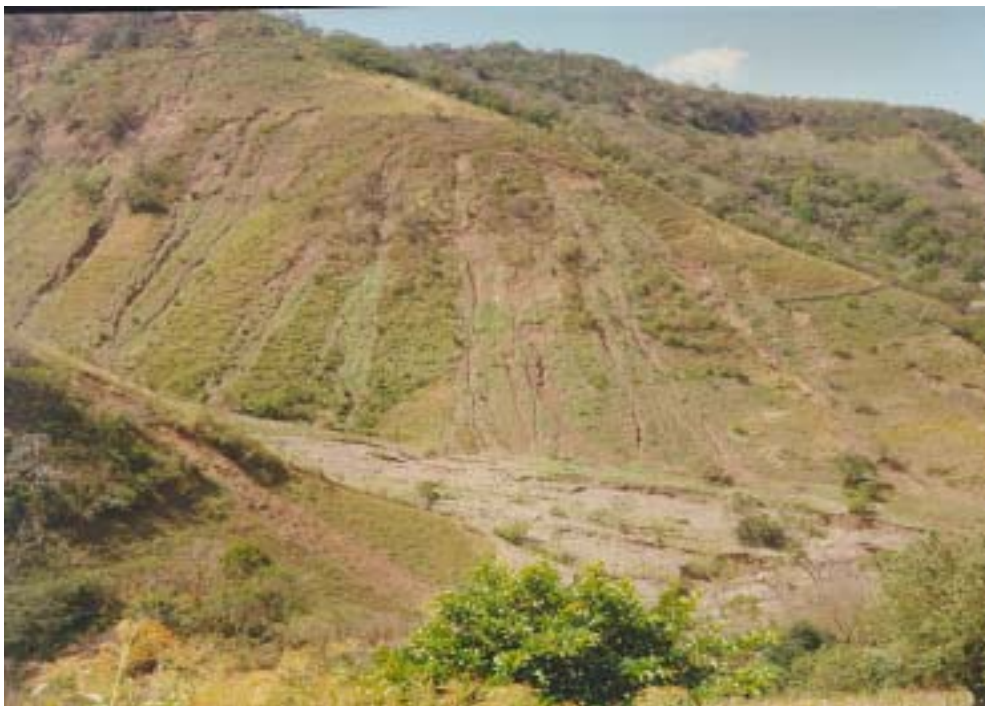
Figure 5. Example of a degraded hillside damaged by Mitch

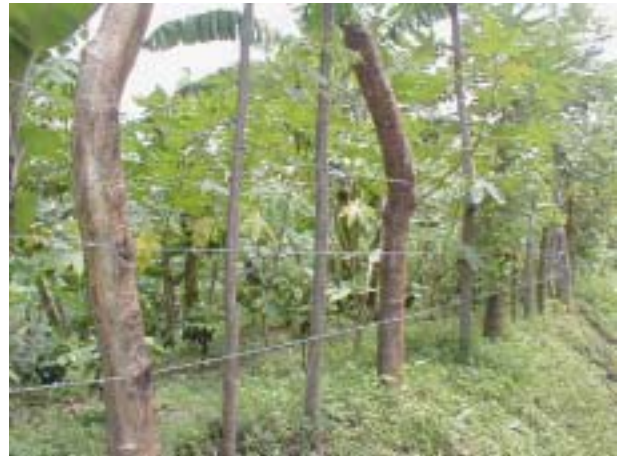
Figure 9. Live fence rehabilitation at Pavona Arriba

- 4.6 km of living fences rehabilitated
- 7,200 trees planted on 89 separate parcels
- 50 parcels rehabilitated by planting 11,650 coffee plants (variety ‘Caturra’).

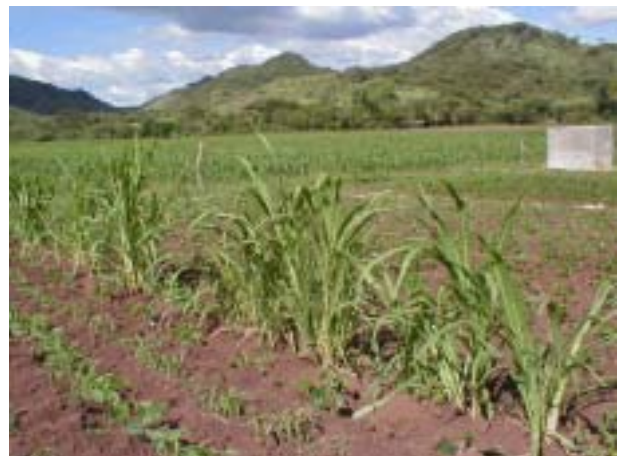
Figure 10. Live barriers of Taiwan grass

- 26.8 km of living fences established
- 86.5 acres of riparian zone reforested
- 10.1 km of Taiwan grass barriers established
- 32,850 trees planted
- 277 acres planted with improved corn, bean and sorghum varieties

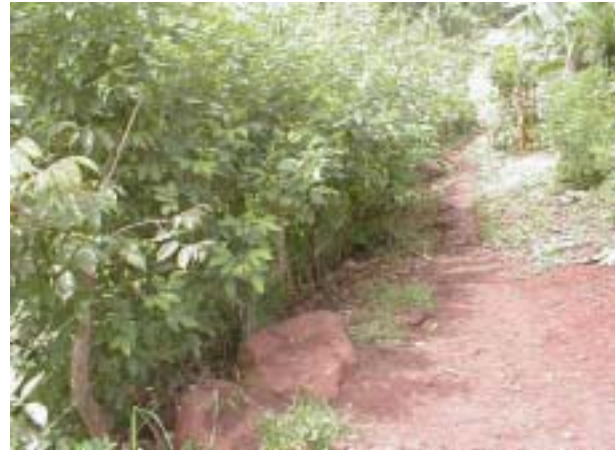
Figure 13. Live fences established in El Bonete

- 93.3 km of living fences established
- 12.7 km of dead barriers established
- 41.5 km of drains constructed
- 65,960 forest trees produced

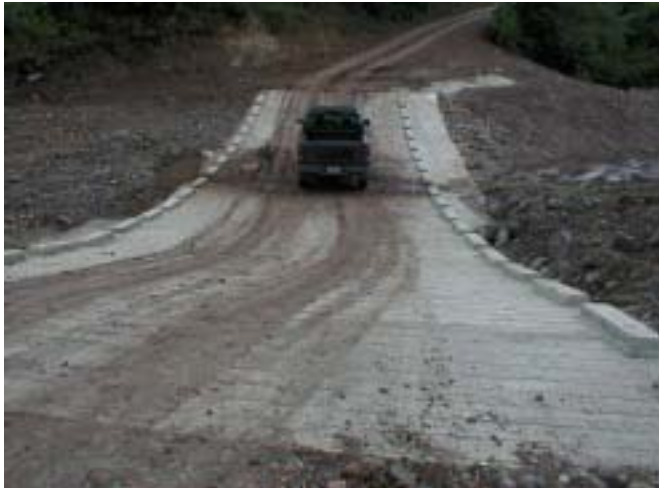
Figure 18a. Ford constructed in Pire River (CHF)

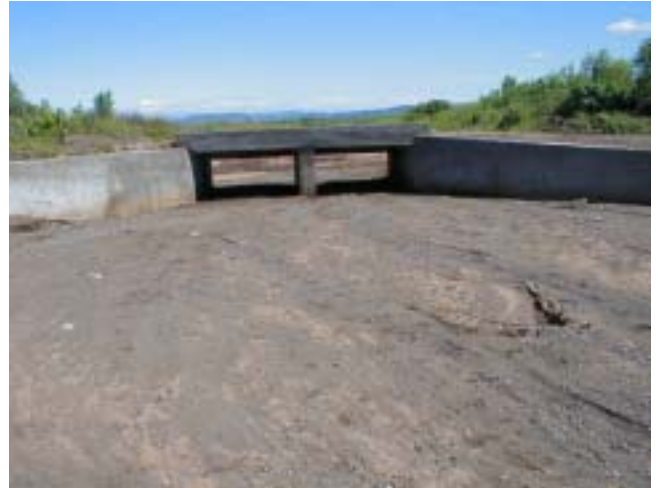
Figure 18b. Box bridge at El Higueral (ADEPAL)

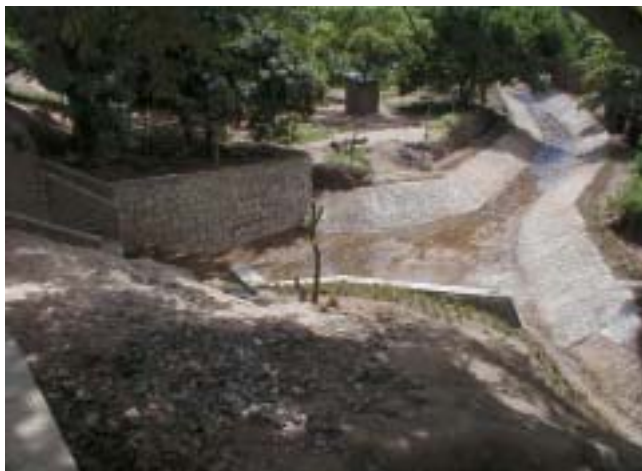
Figure 18c. Drainage channel rehabilitation (AMUNSE)

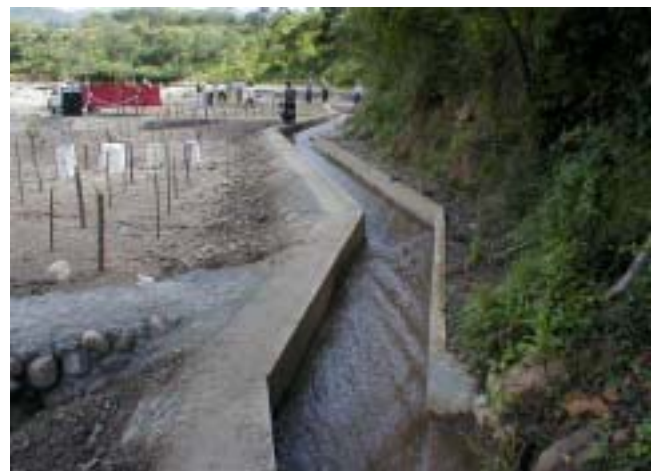
Figure 18d. Rehabilitated irrigation canal (COONORTE)

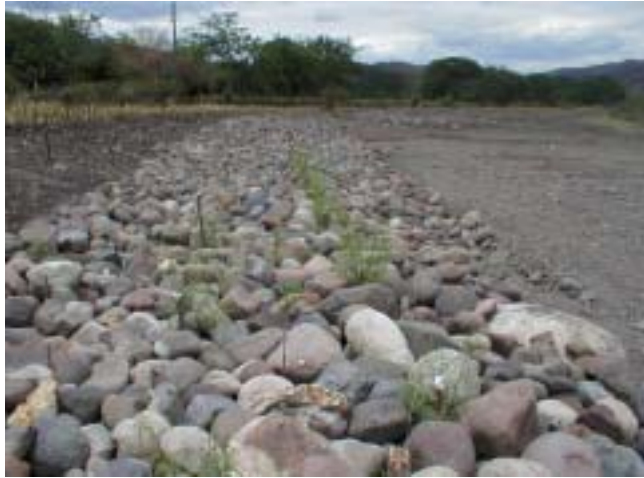
Figure 18e. Early stage of stream bank restoration using bio-engineering techniques (CLUSA-Zamarano)

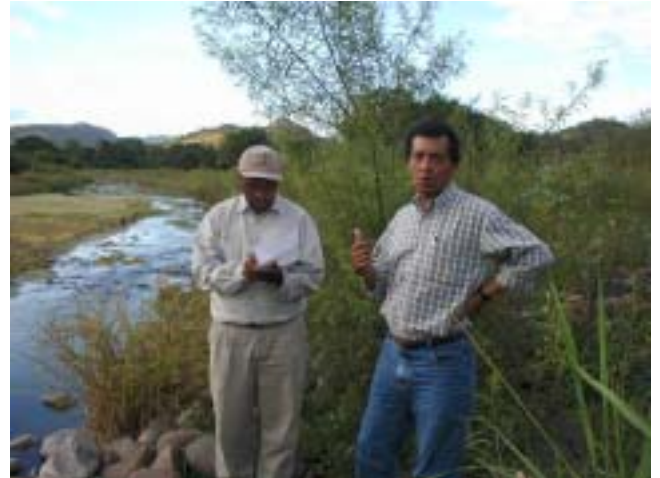
Figure 18f. Same area as in 18e after vegetation has become established (CLUSA-Zamarano)

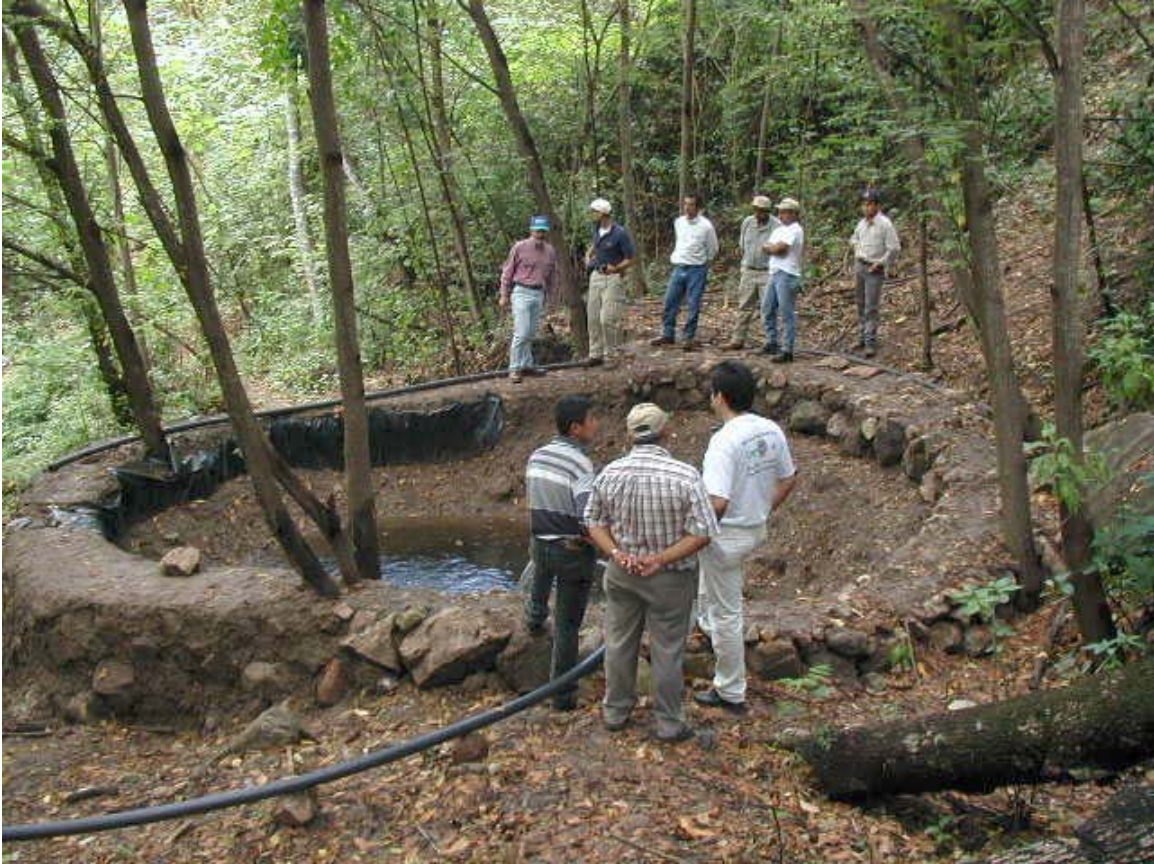
Figure 20. Example of reservoir constructed by CHF in Esteli Department

Reservoirs were of two types: 1) plastic lined with compacted clay and 2) clay mixed with a small proportion of sand, dirt and cement. Figure 20 shows a typical plastic type of reservoir. Irrigation systems using appropriate technology were sometimes constructed to complement the reservoirs. The systems constructed were sprinkler and drip irrigation systems (tape type and screw type).

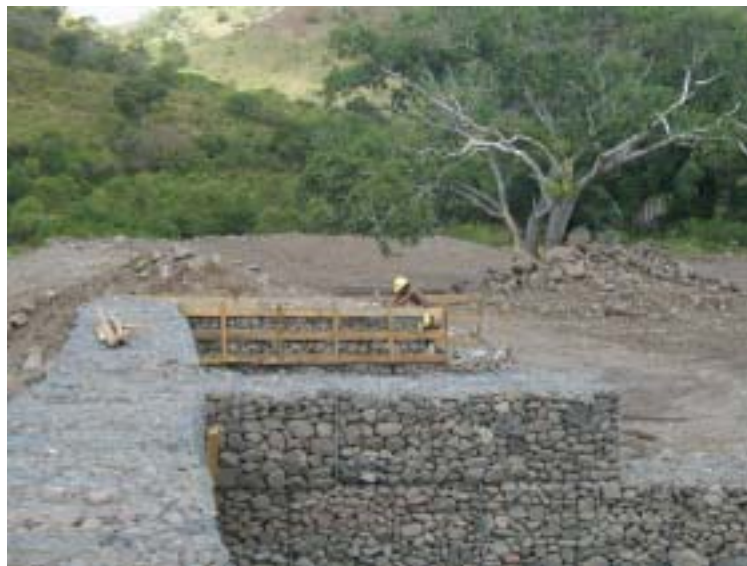
Figure 21. Gabion construction to reinforce banks of the Pire River

This project near Santa Teresa was designed to benefit 12 communities with a total population of approximately 3,000 families located along the banks of the Pire River. Condega is one of the municipalities (within Esteli Department) that suffered the greatest loss of life, housing, crops, household goods, livestock, and poultry in all of Nicaragua from Hurricane Mitch. USDA devoted considerable technical assistance in terms of design and oversight during implementation. Figures 21-23 shows scenes from the project site—one of the larger and more complex projects of its type.

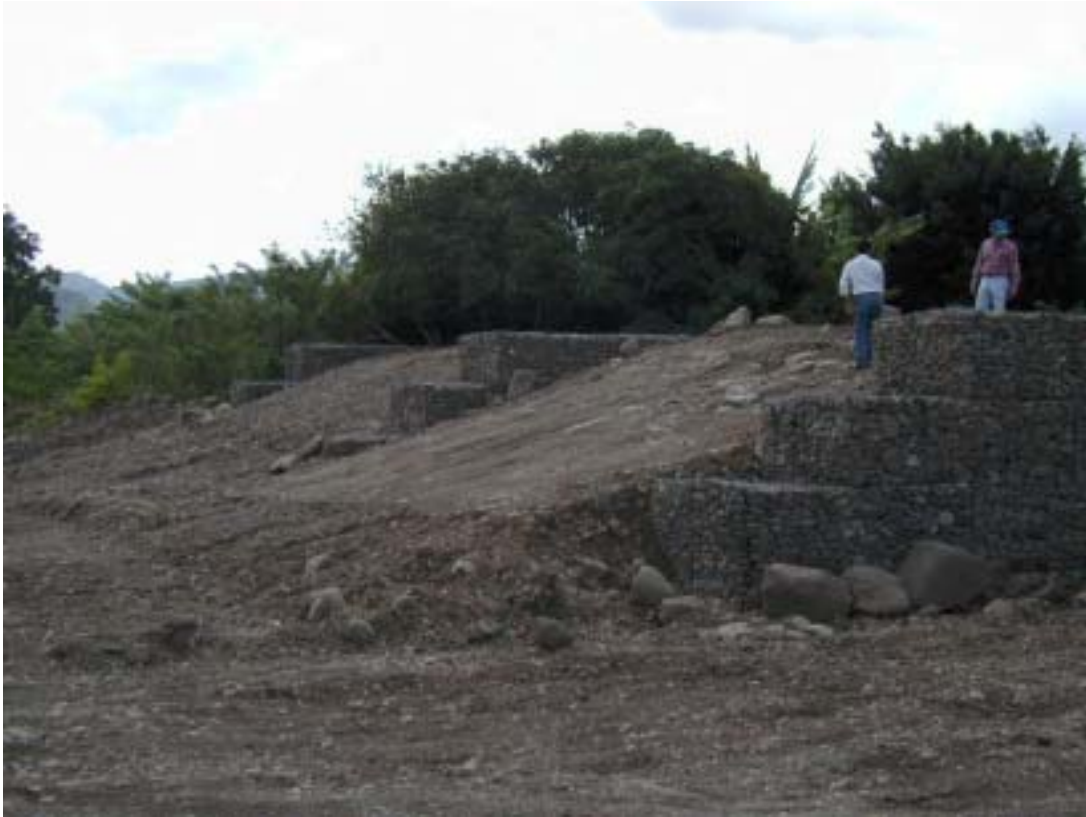
Figure 22. Stabilization of stream banks

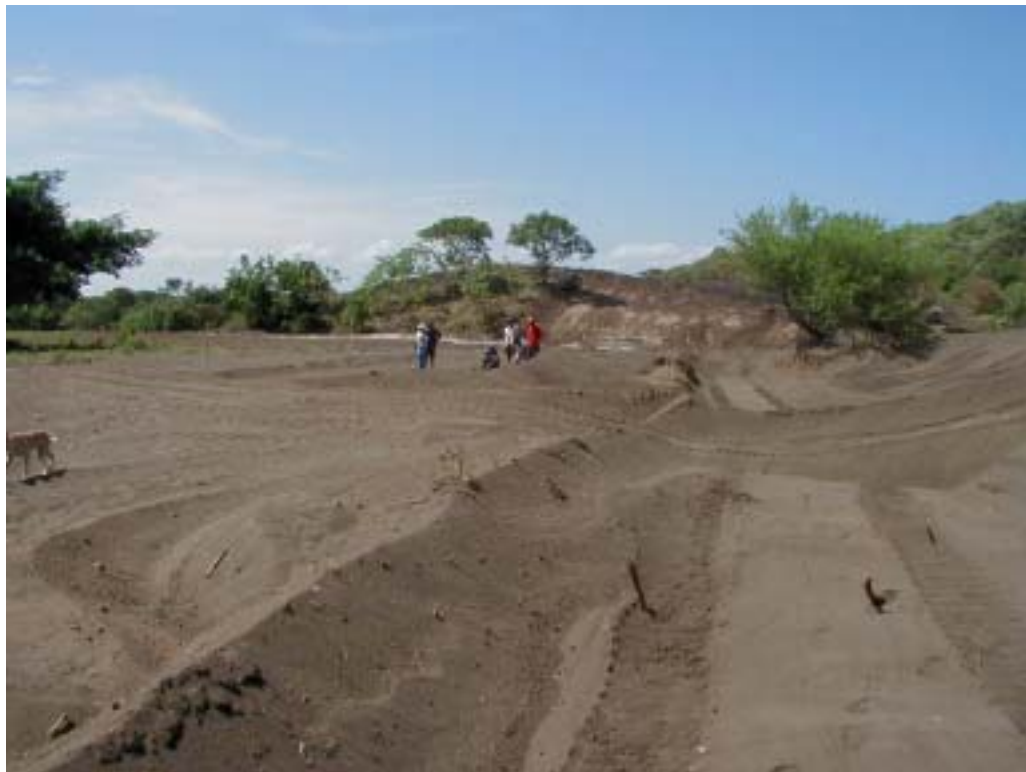
Figure 25a. Pre-construction photo of Puerto Momotombo site

This project protected the downstream community from flooding and consisted of three components. These were gabion dikes at two critical points, a masonry concrete low water crossing, and stream barbs to protect vertical banks along an adjacent floodplain. Figures 25a and 25b show pre-construction and post-construction views of the project site.

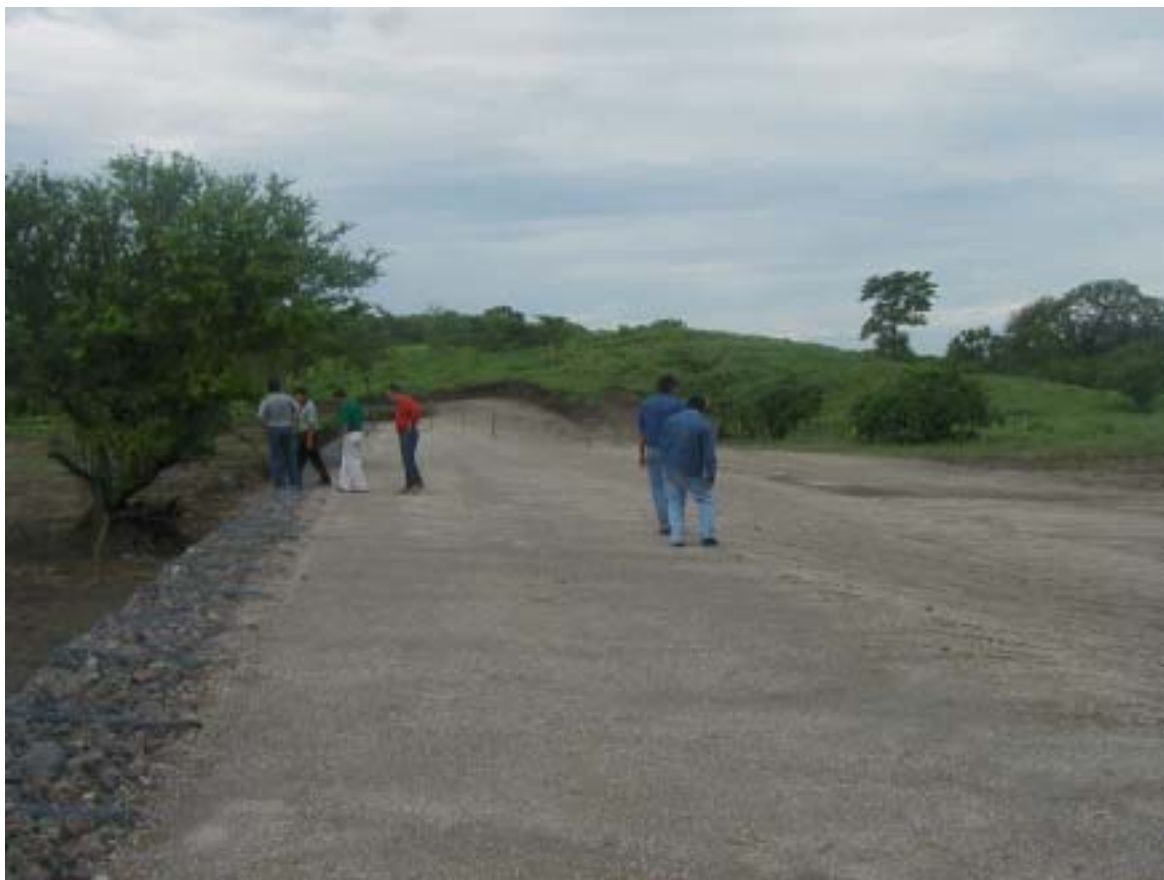
Figure 25b. Post-construction photo of Puerto Momotombo gabion dike

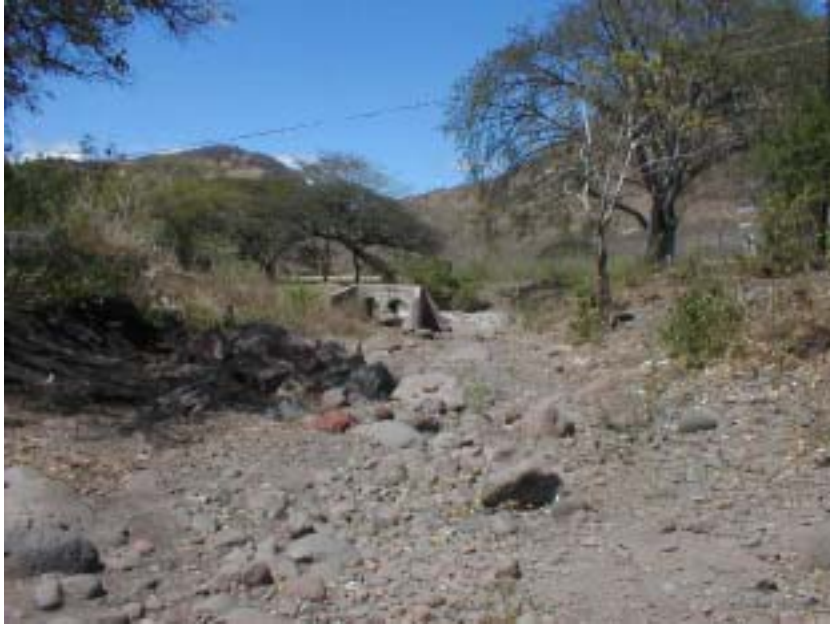
Figure 26a. El Hatillo site damaged by Hurricane Mitch

This project constructed a new bridge thus establishing an important farm-to-market road connection between the local El Hatillo community and regional agricultural markets. Stream bank stabilization was undertaken adjacent to the new bridge to protect the area from flooding. USDA also collaborated with CARE in rebuilding local irrigation systems for small farmers near to this site. Figures 26a is a shot of the damaged remnants of the old bridge and road after Mitch. Figure 26b celebrates the inauguration of the completed project in November 2001.

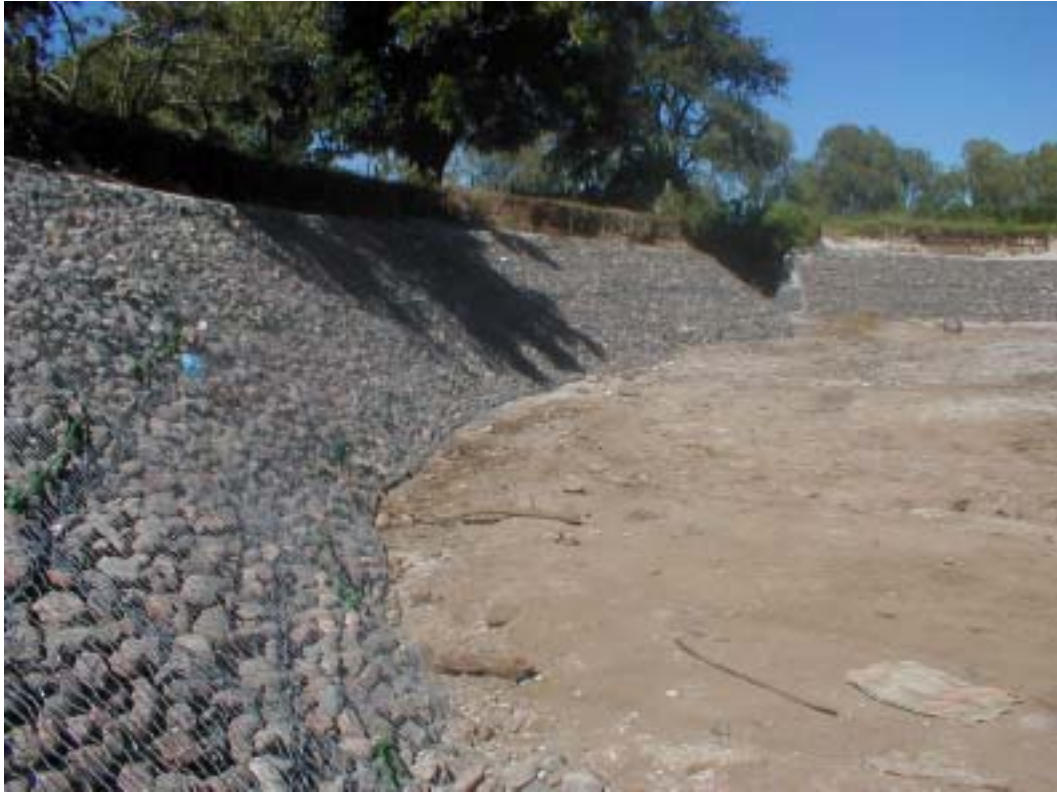
Figure 27. Completed section of La Quimera bank protection project

This work consists of constructing gabion stream barbs and structures along the outer riverbanks in order to protect the adjacent community from flooding and loss of property.

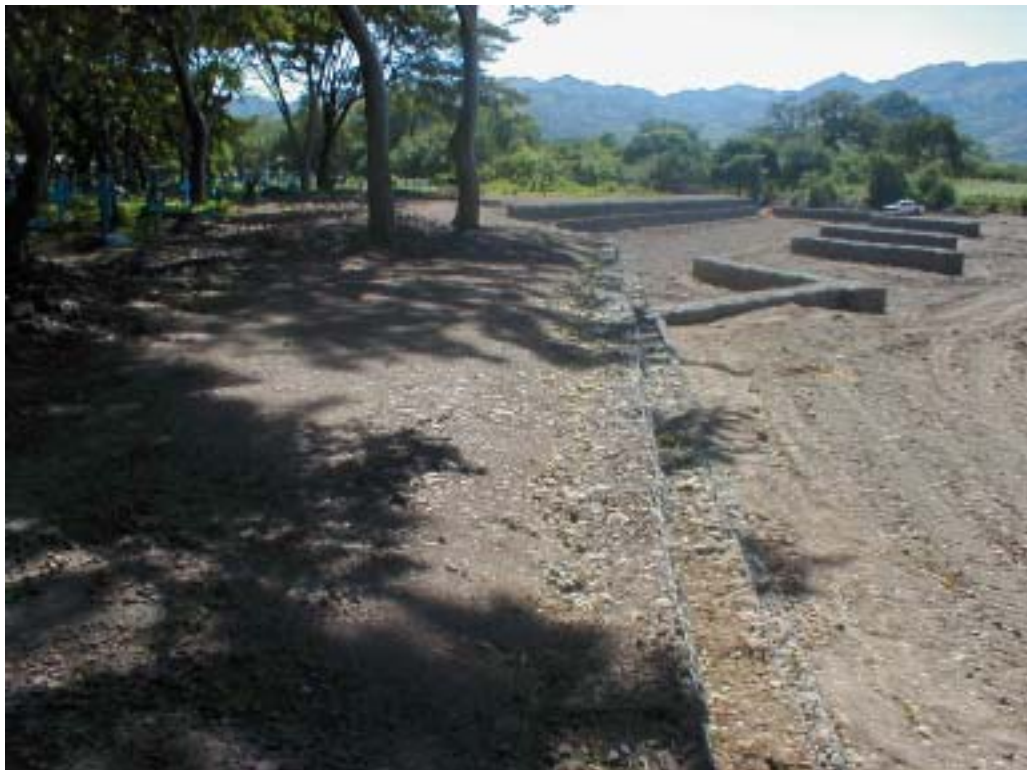
Figure 28. Completed section of La Quimera bank protection project
